Manhole Inspection Summary

Manhole # S37YY_033MH

Insp Date: **12/29/06 9:35 AM**

Location Address: **600 OLD YORK RD**

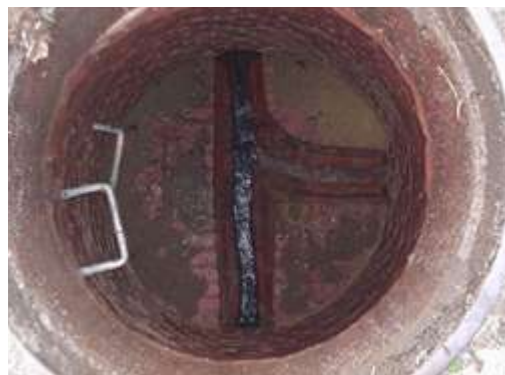
Top View

Barrel infiltration. Bench debris.

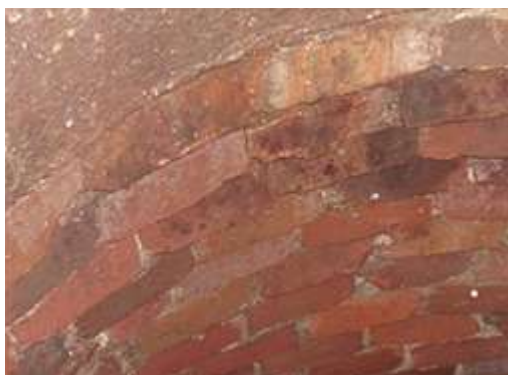
Defect

Frame leaks. Adjustment infiltration.

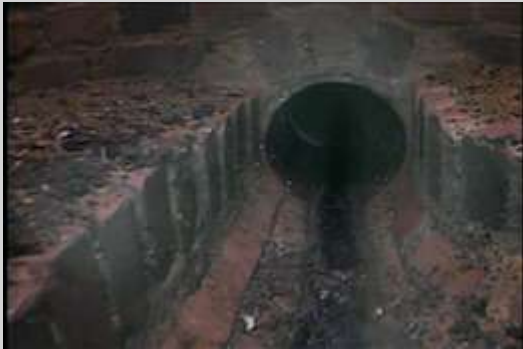
8 in. Circular Gravity Sewer Pipe Out @ 12 O'Clock

Infiltration: **Evidence** Pipe Seal Cond: **Unknown**
